REGIONAL DEER-VEHICLE
ACCIDENT RESEARCH

Final Report
November 1979

1. Report No. FHWA-CO-RD-79-11		2. Government Accession No.		3. Recipient's Catalog No.	
4. Title and Subtitle REGIONAL DEER-VEHICLE ACCIDENT RESEARCH				5. Report Date November 1979

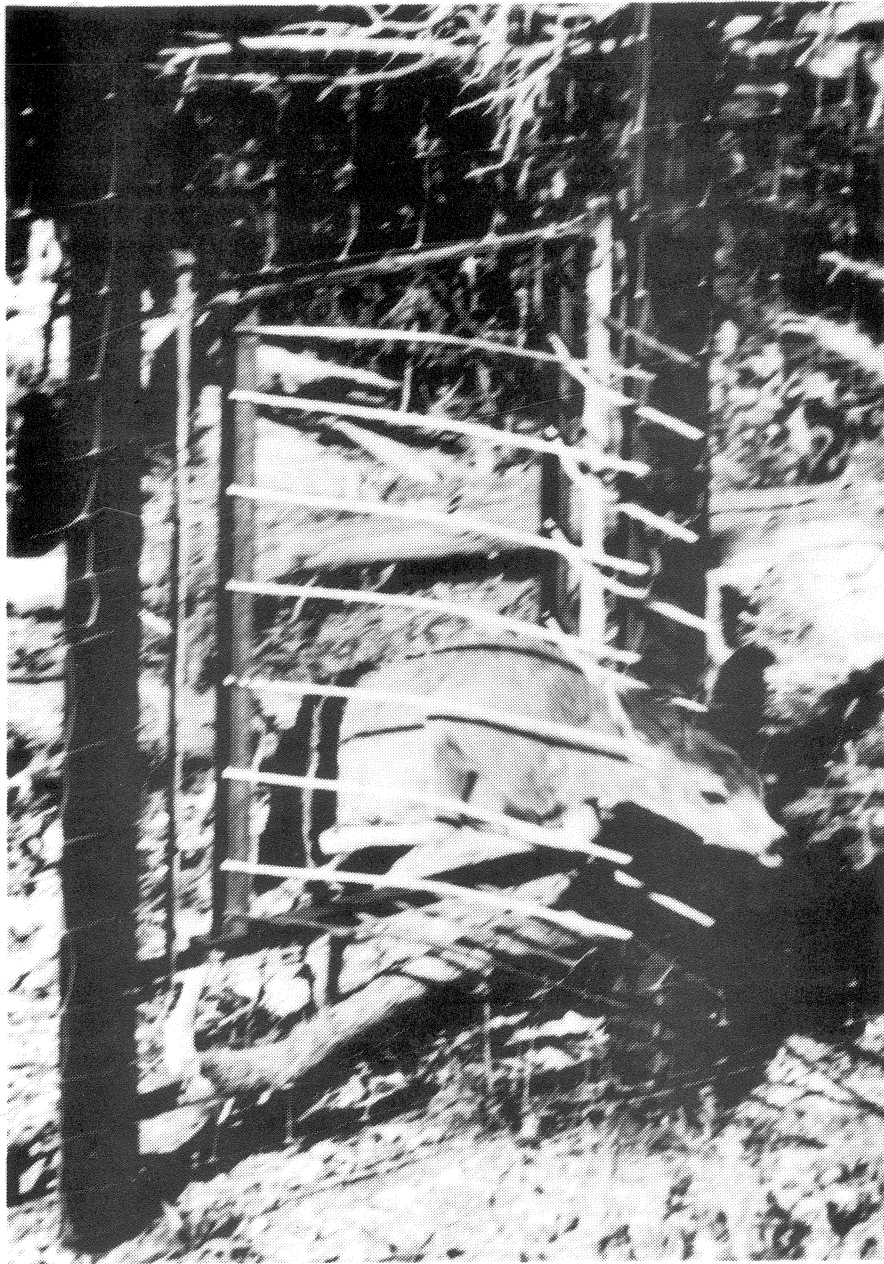
Fig. 3. A one-way deer gate showing a deer bounding through the structure. Photo by D. F. Reed.

One-way deer gates (Fig. 3) were located in the Vail, Avon, Edwards, and Eagle 2.44 m fences. These gates were checked periodically for passages and activity by checking tracks in the raked soil at the gate entrance and exit.

One-way gates were effective in allowing deer to escape the highway rights-of-way when they were strategically located. When one-way gates are recommended for installation in 2.44-m fences, they should be located near drainages or vegetative cover. Recommendations for spacing of the gates and other details were covered by Reed et al. (1974a) and Reed (1981G).

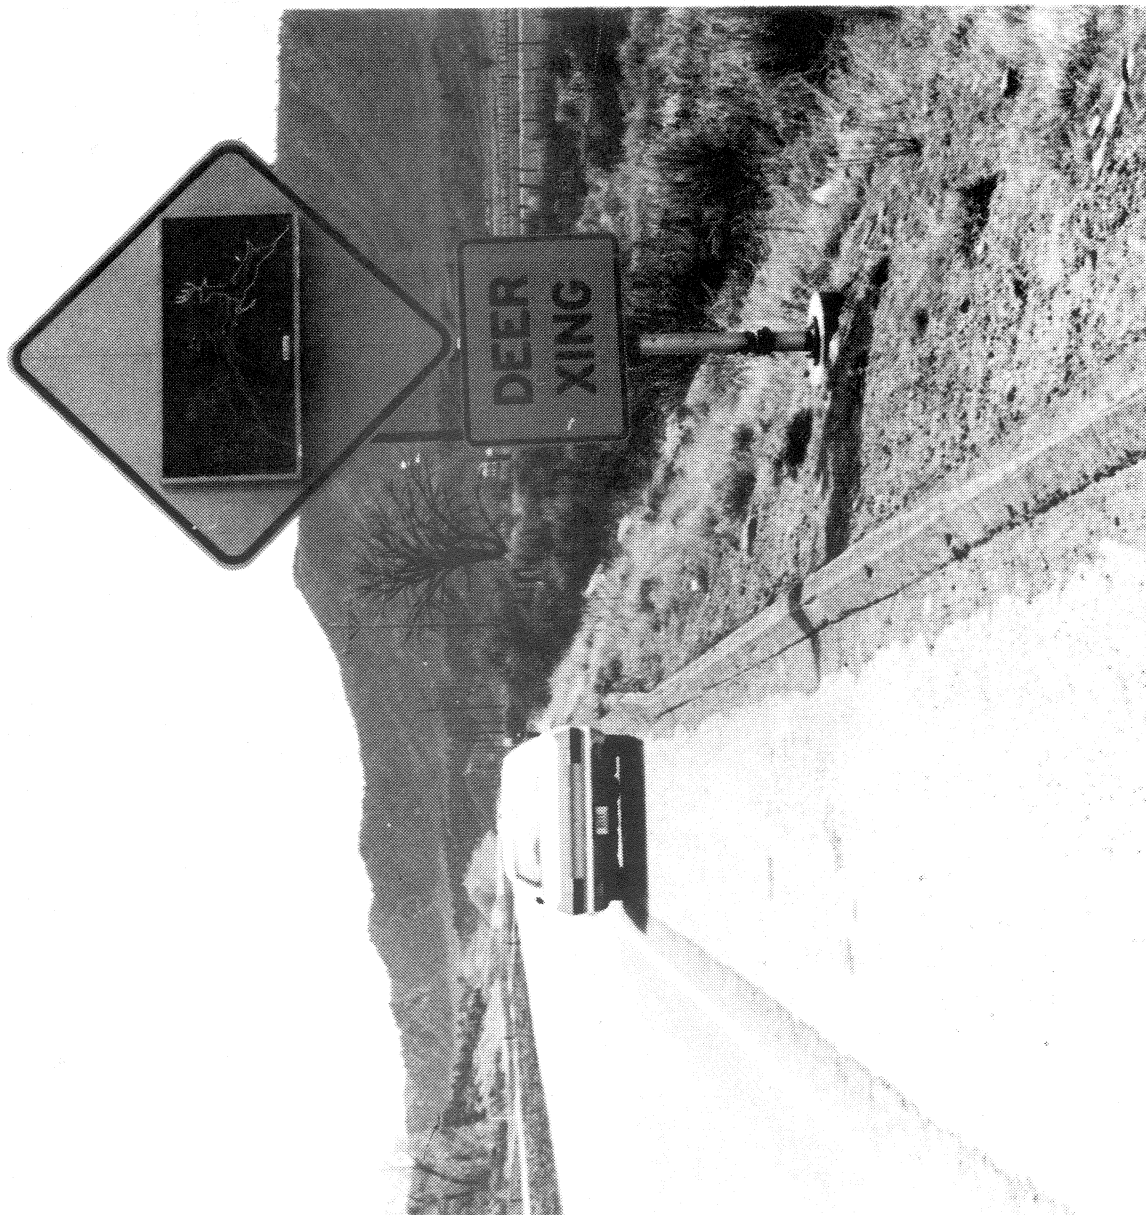
Fig. 6. The lighted, animated deer crossing sign is shown turned toward traffic with the lighted silhouette sequence beginning. Photo courtesy of the Colorado Division of Highways.

The lighted, animated deer crossing sign (Fig. 6) had a reflectorized yellow, diamond-shaped background (1.83 x 1.83 m) with four silhouettes of deer made of neon tubing lighted in sequence from right to left across the sign. Two signs were constructed so they could be easily swung away from approaching traffic. In the on position, the signs were locked into place facing traffic and the neon lights were activated. The signs were turned on and off for alternate weekly periods during January - March periods. Other methods were similar to those used during the highway lighting tests and are described further by Pojar et al. (1975).

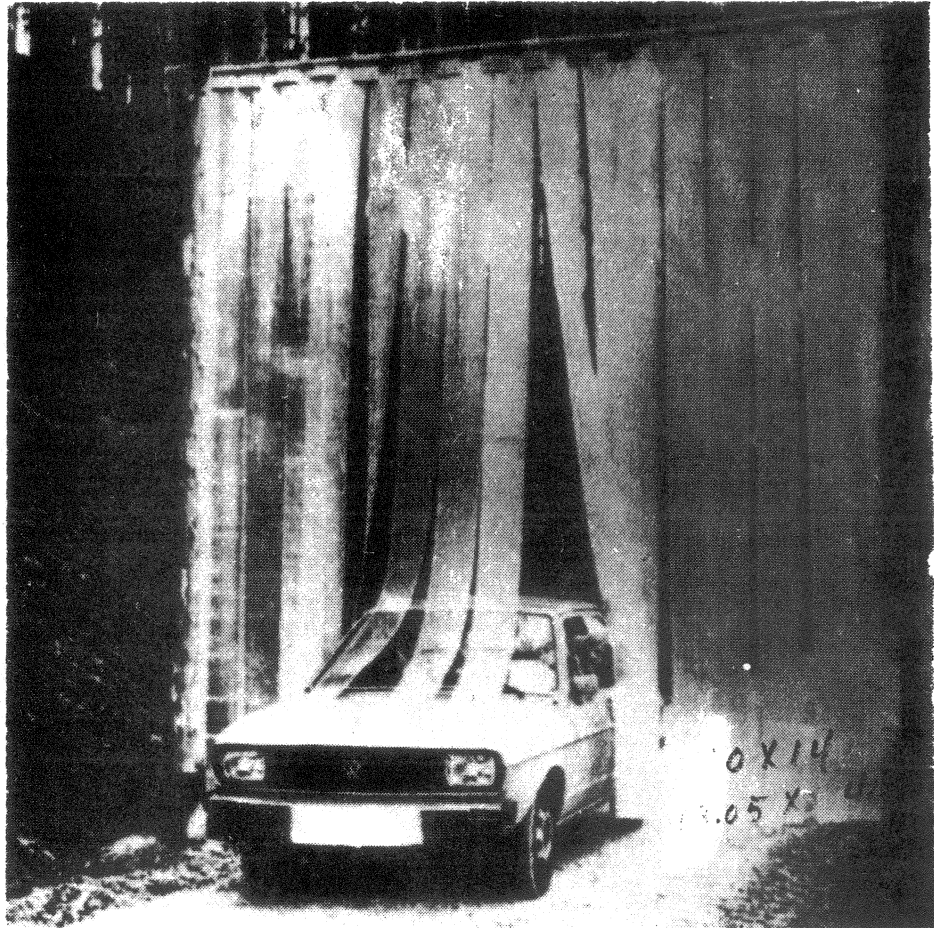
Fig. 9. Reportedly plastic strip curtains have kept animals inside game parks in West Germany's Harz Forest Region. Effectiveness was based on light reflection from the plastic strips. AP photo.

prototypes (e.g. Fig. 9) were not tested. However, based upon the responses of deer to various aspects of the five prototypes, it is estimated that they would not be effective. Where 2.44 m vehicle gates (manual, "push-type," or automatic) are not feasible, no effective guard can be recommended as a result of this study.
